Caldwell House, East Renfrewshire

Conservation Plan

September, 2020

Simpson & Brown/AOC

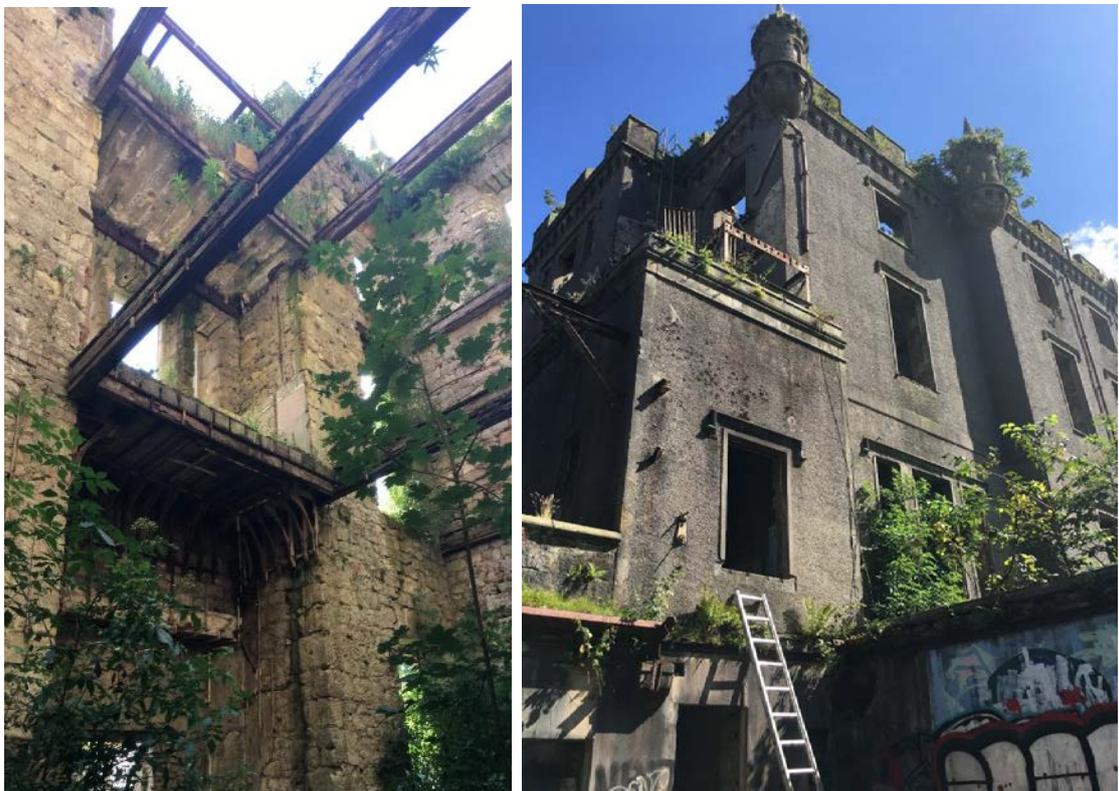
The current condition of the house is poor. There was a major fire in the house in 1995 when the entire interior and roof was lost. The Keeper's House has also lost its interior and roof.

Figure 2 Caldwell House, interior and south west corner

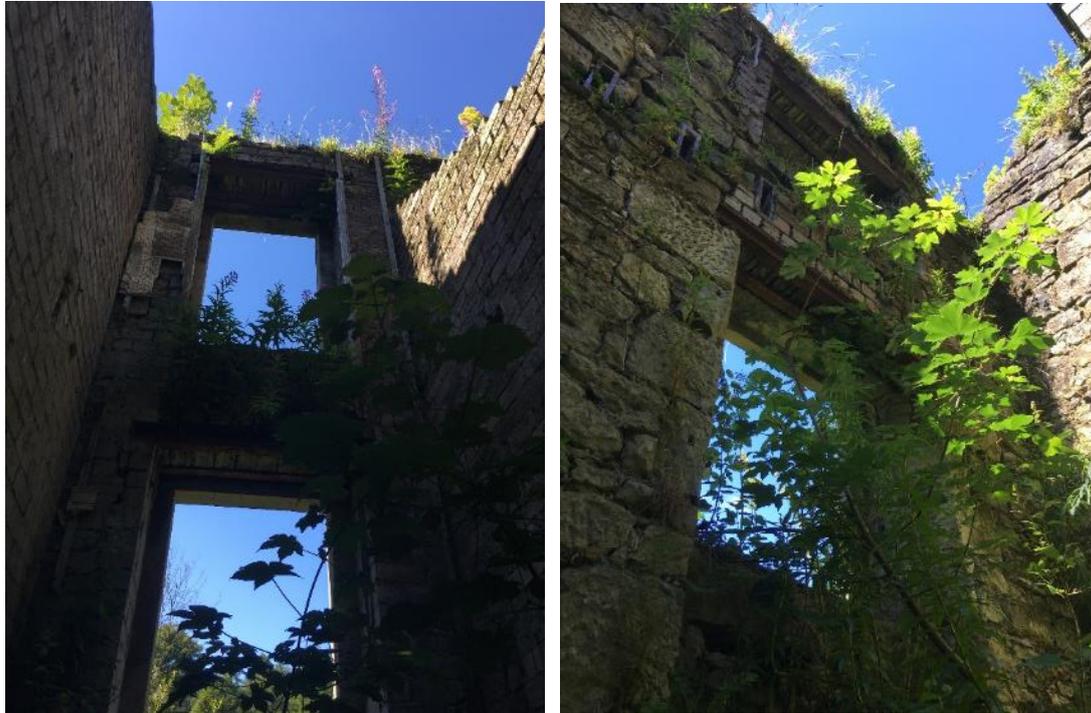
The Category B Keeper's House was altered at sometime early in the 20th century. The building was still roofed in 1997 but has been extensively damaged by fire since.

Figure 17 Keeper's House interior

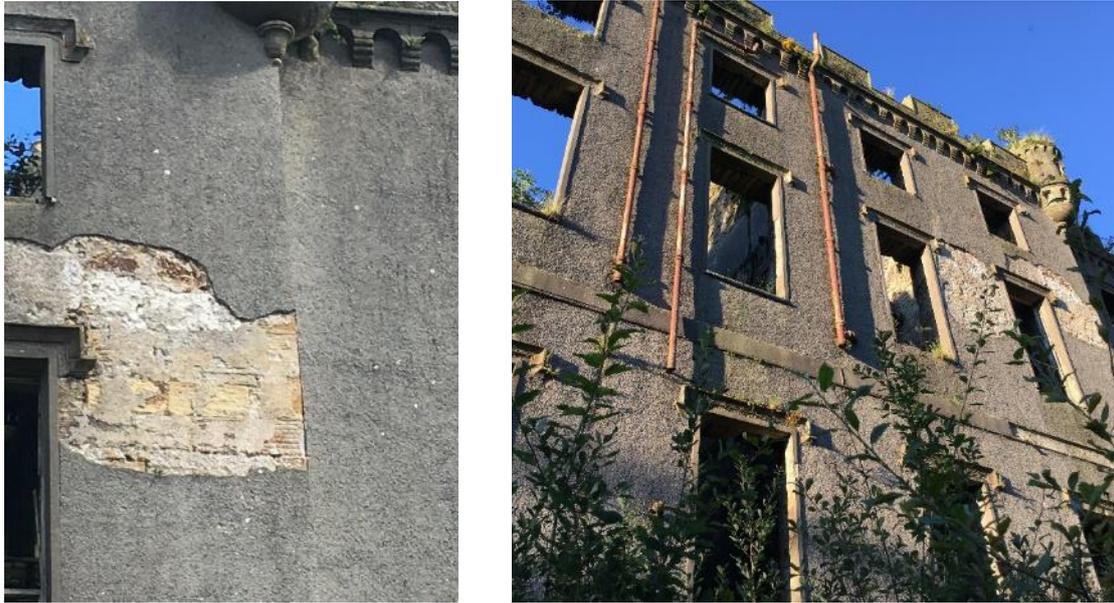
with ashlar. However, it is clear that this building was built to be finished with render. Fragments of the original lime render survive on the garden front to the south.

Figure 28 Lime render on the garden to the south front

The current coating of cement is likely either to date from the 19th century or from the time that the building was bought as a hospital. The latter possibility is suggested by the way that render of the same character continues across the hospital buildings to the west and east. When the render was reapplied, the original detailing around the windows was remade as render stops. The original raised margin might have eroded or has been cut off. The margin survives in some positions, for instance around the arches over the first floor windows on the east and west outer bays.

The external walls should have cement covering removed, masonry repaired and given a lime covering finished with limewash. The resulting appearance would be bright and strong. It would be more related to the appearance to the restored Kenwood House, and neo-classical house by Adam, than the current mid-grey appearance. Caldwell House is unusual amongst Adam style houses in being finished with render rather than ashlar stone. It is almost certain that the original lime based render would be intended to imitate the light colour and finish of freshly quarried ashlar sandstone.

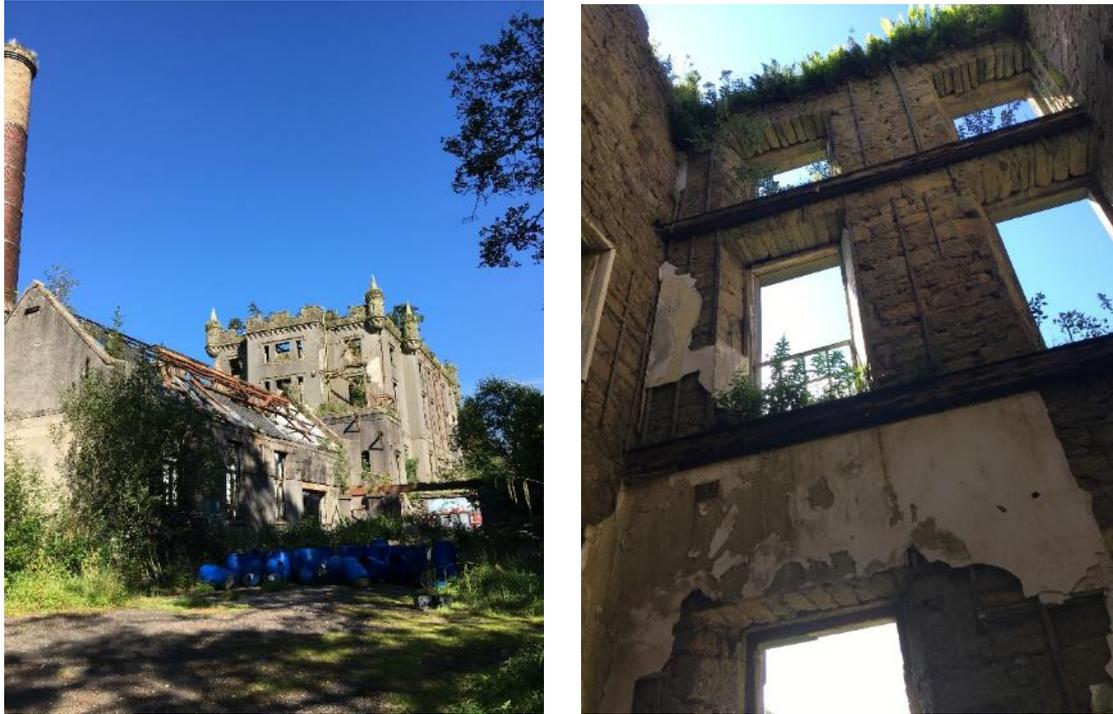
Figure 48 Caldwell House – condition

Given that this is a roofless shell and has been in poor condition for most of the last 50 years and has been a burnt out shell for the last quarter of a century, the masonry is in remarkably good condition. The parapets look sound. The cope and parapet stones would have to be tested when access is available and it is likely that the copes would be rebedded. Vegetation needs to be removed. Some of the merlons might be flues. The main problem with the parapets and the corner bartizans is grass and weeds. These could be cleared off and the roots thoroughly removed.

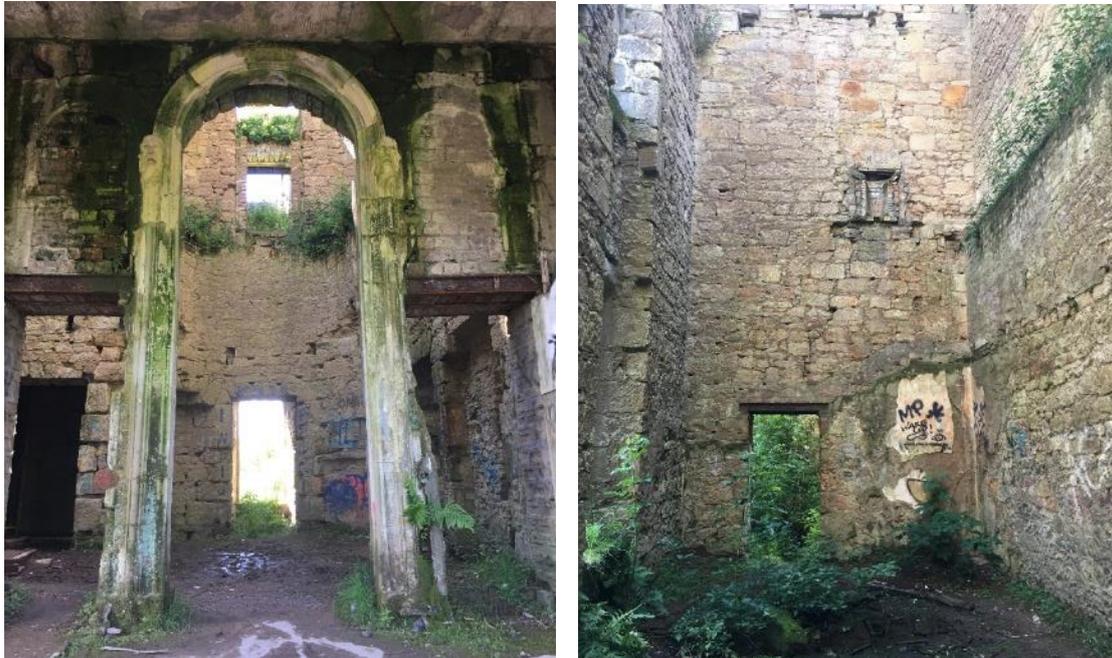
Figure 49 Caldwell House – interior condition

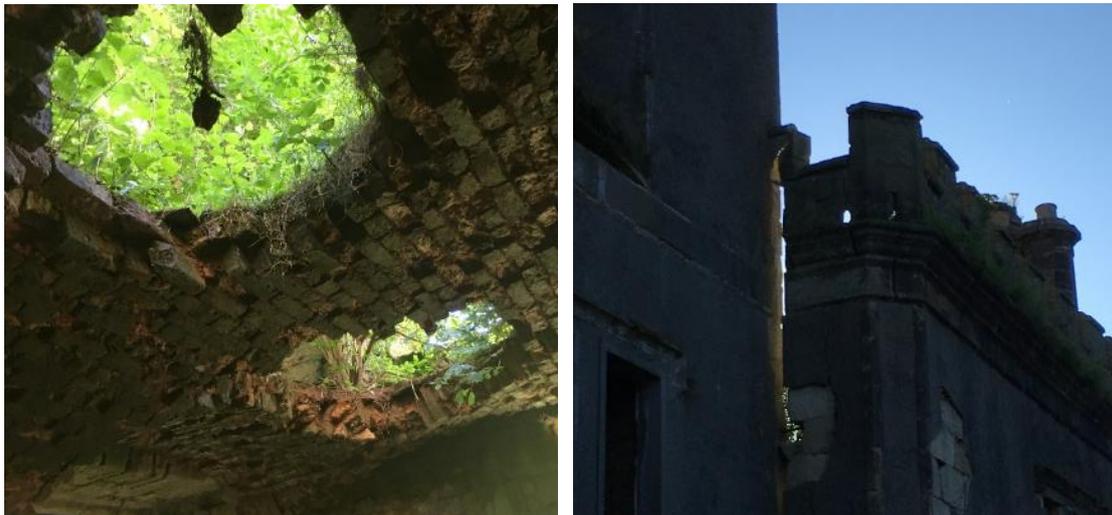
As with the structure to the north, the south west extension is in poor condition.

Figure 50 Caldwell House – structural condition of vault and c19th extension

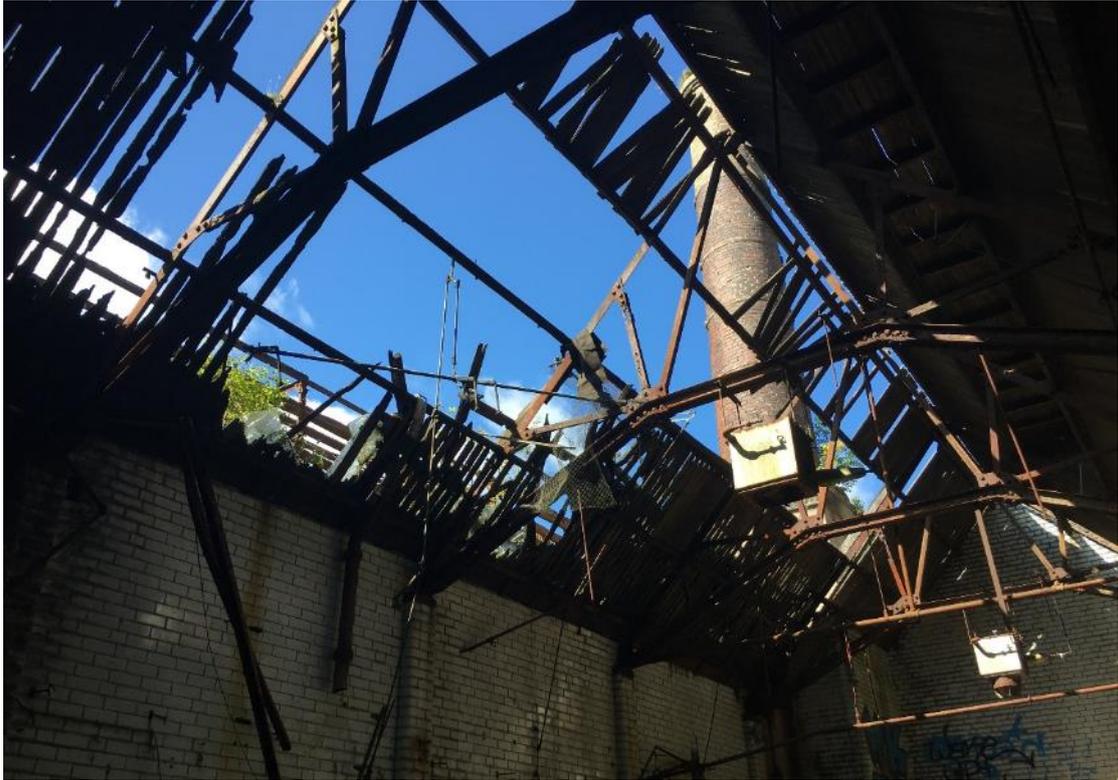
The roof coverings have almost completely failed with only a few areas of slates left. The roof structure is metal and is extensively damaged.

Figure 51 20th Century western extension, condition

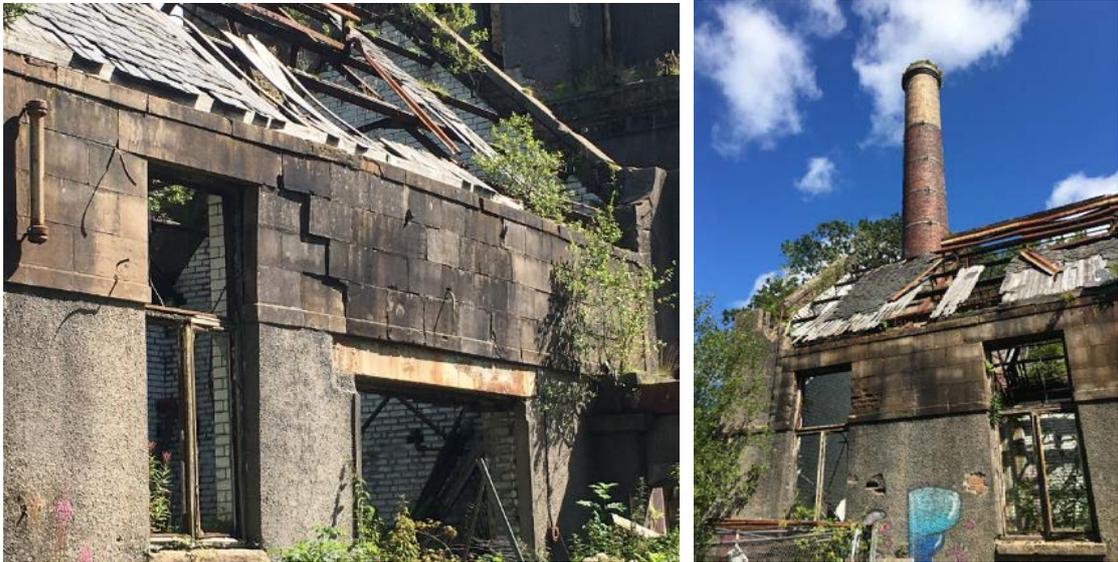
Figure 52 20th Century western extension, condition
